i-PCGRID Workshop 2018

Power Line Carrier Holes and Field Trial Tests

Presented by: Tony Bell
PLC Product Manager
AMETEK Power Instruments
Pulsar Products
www.ametekpower.com

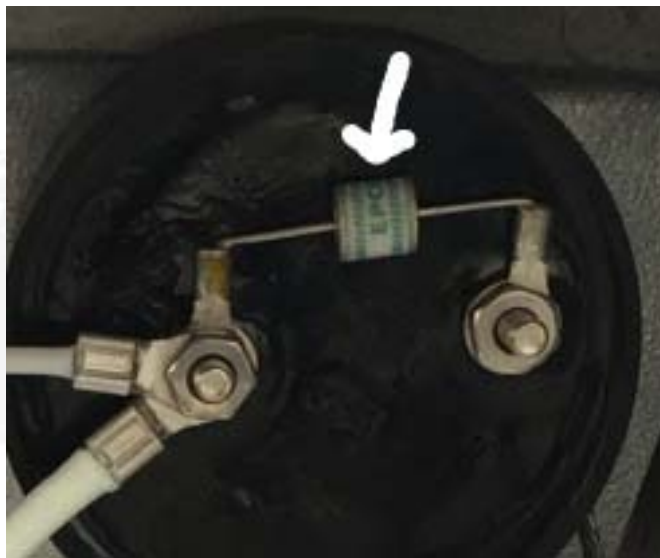
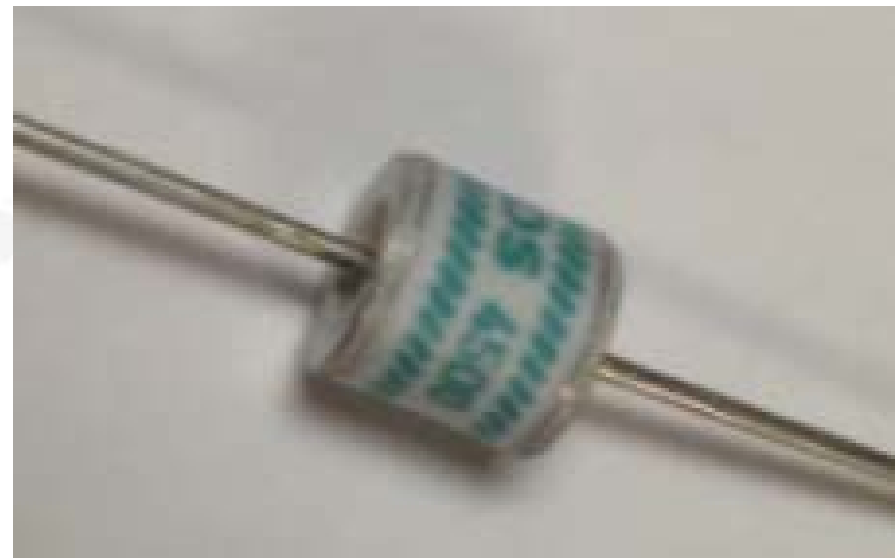
Gas Tubes - Advantages

- Being used on many line tuners & CCVTs as they are more precise and sealed therefore not being exposed to contamination and do not require setting.

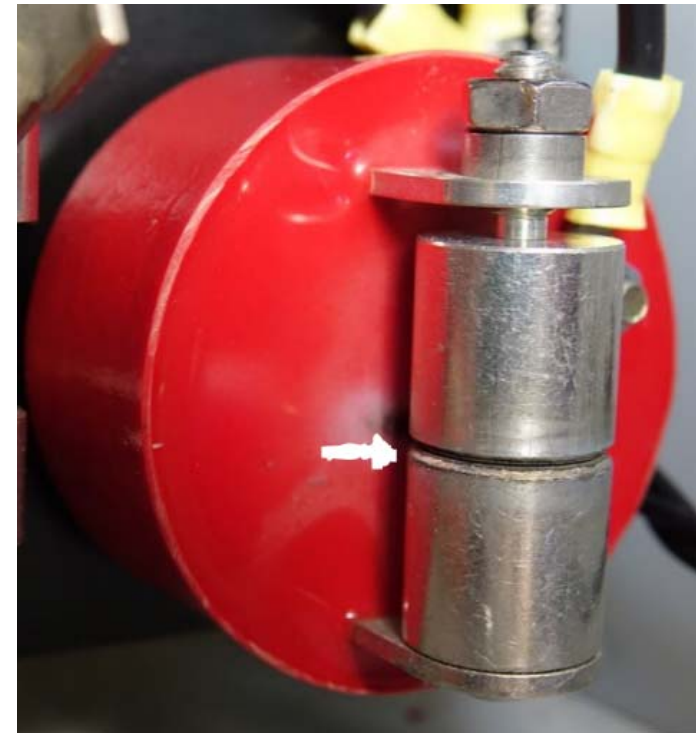
Air Gaps - Advantages

- Still popular due to being able to physically see and clean the gap.
- They tend to extinguish arcs faster than gas tubes when in good condition.
- There are various types ranging from simple metal washers spaced apart to more sophisticated types.
- White arrow shows the thin gap. →

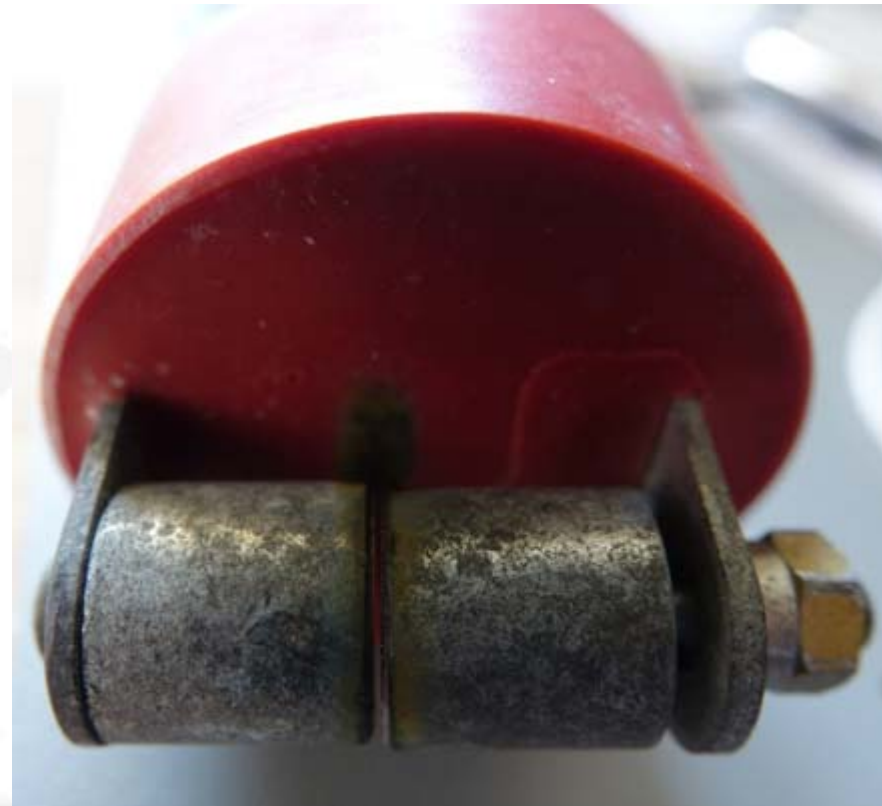
Air Gaps - Disadvantages

- Get worse with time from carbon build up and pitting that occur during arcing, humidity/moisture/dust, oxidation, & insects. They can also be misadjusted.
- Photo shows corrosion and non-parallel surfaces of a poorly maintained air gap.

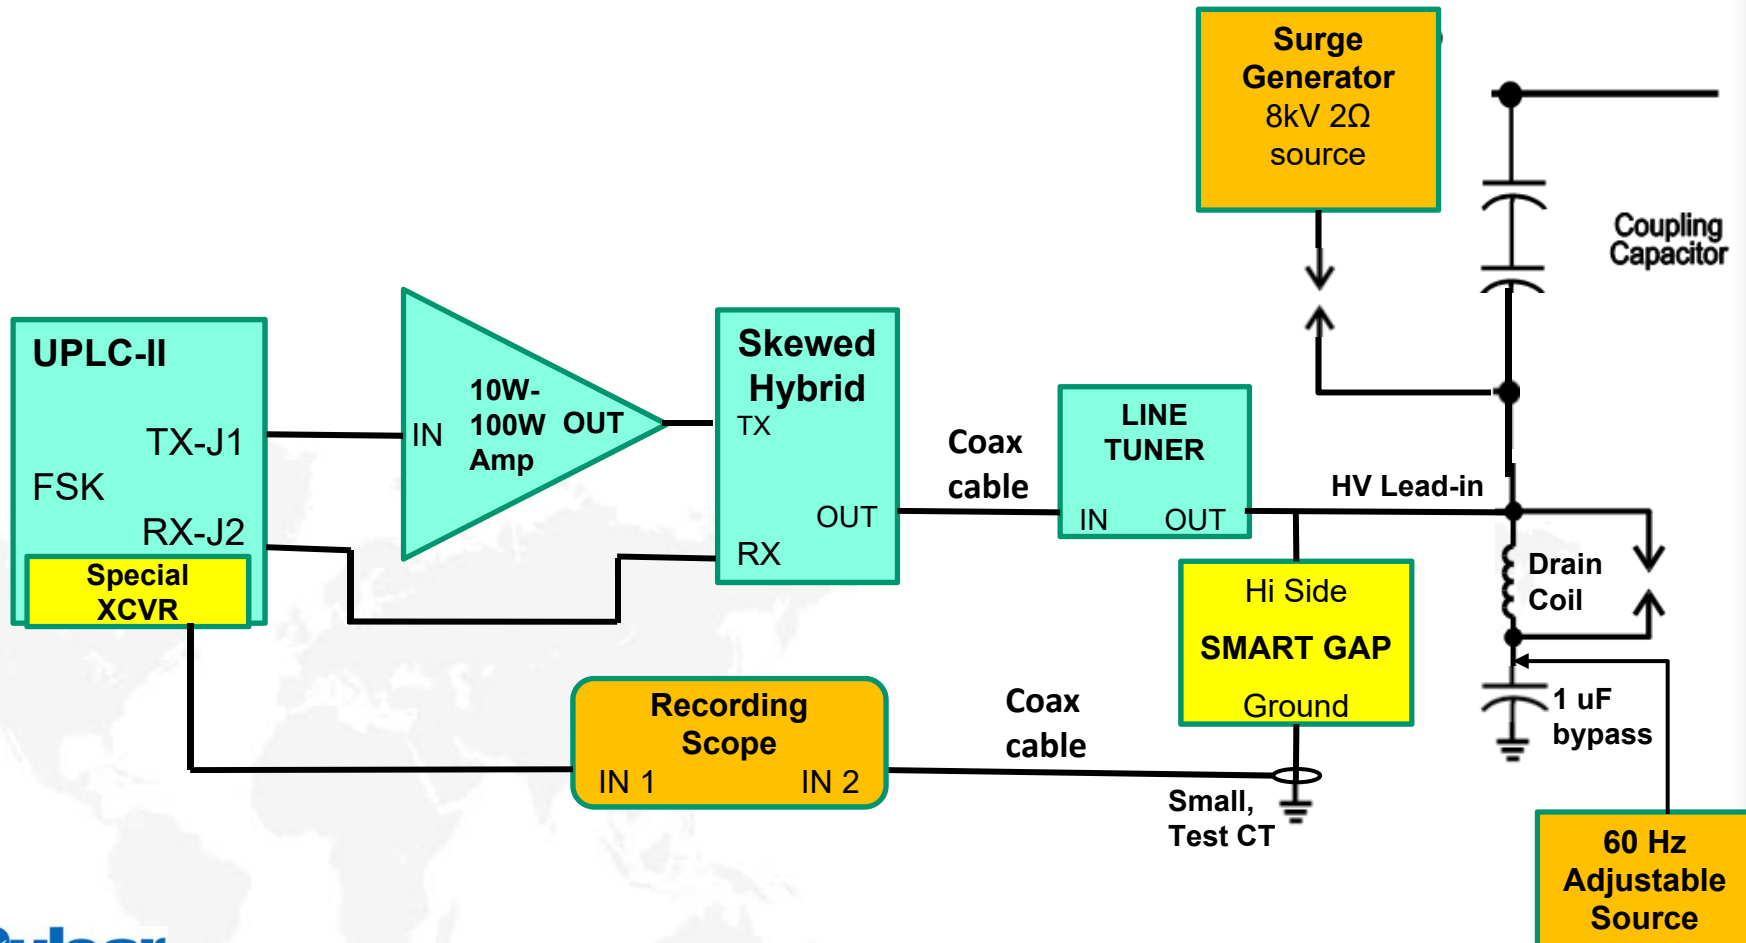
Lab Test Set Up for Testing Carrier Holes

Note: All tests were run with single 8KV (1.2 X 50 usec) surges applied a few seconds apart at a max of 4000A peak.

1. Extensive lab testing was done that included many tens of thousands surges. We called a carrier hole any loss of carrier for > 2 msec.
2. Carrier holes were produced with an air gap in the line tuner, but only with the gap being “compromised” (set wrongly, damaged, or dirty).
3. Able to produce carrier holes much easier with the standard gas tube gap in the tuner & the carrier hole occurrence frequency increases with an increase in the amount of constant RF & 60 Hz power that is across the gap.
4. Protectors (especially gas tubes) fire at a much higher voltage than is required to keep them conducting. RF from the PLC TX + 60 Hz voltage across the drain coil can keep a protector conducting long after the surge has dissipated. This can cause elongated carrier holes & noise during the arcing time of the gap with about 50% lasting over 8 msec.

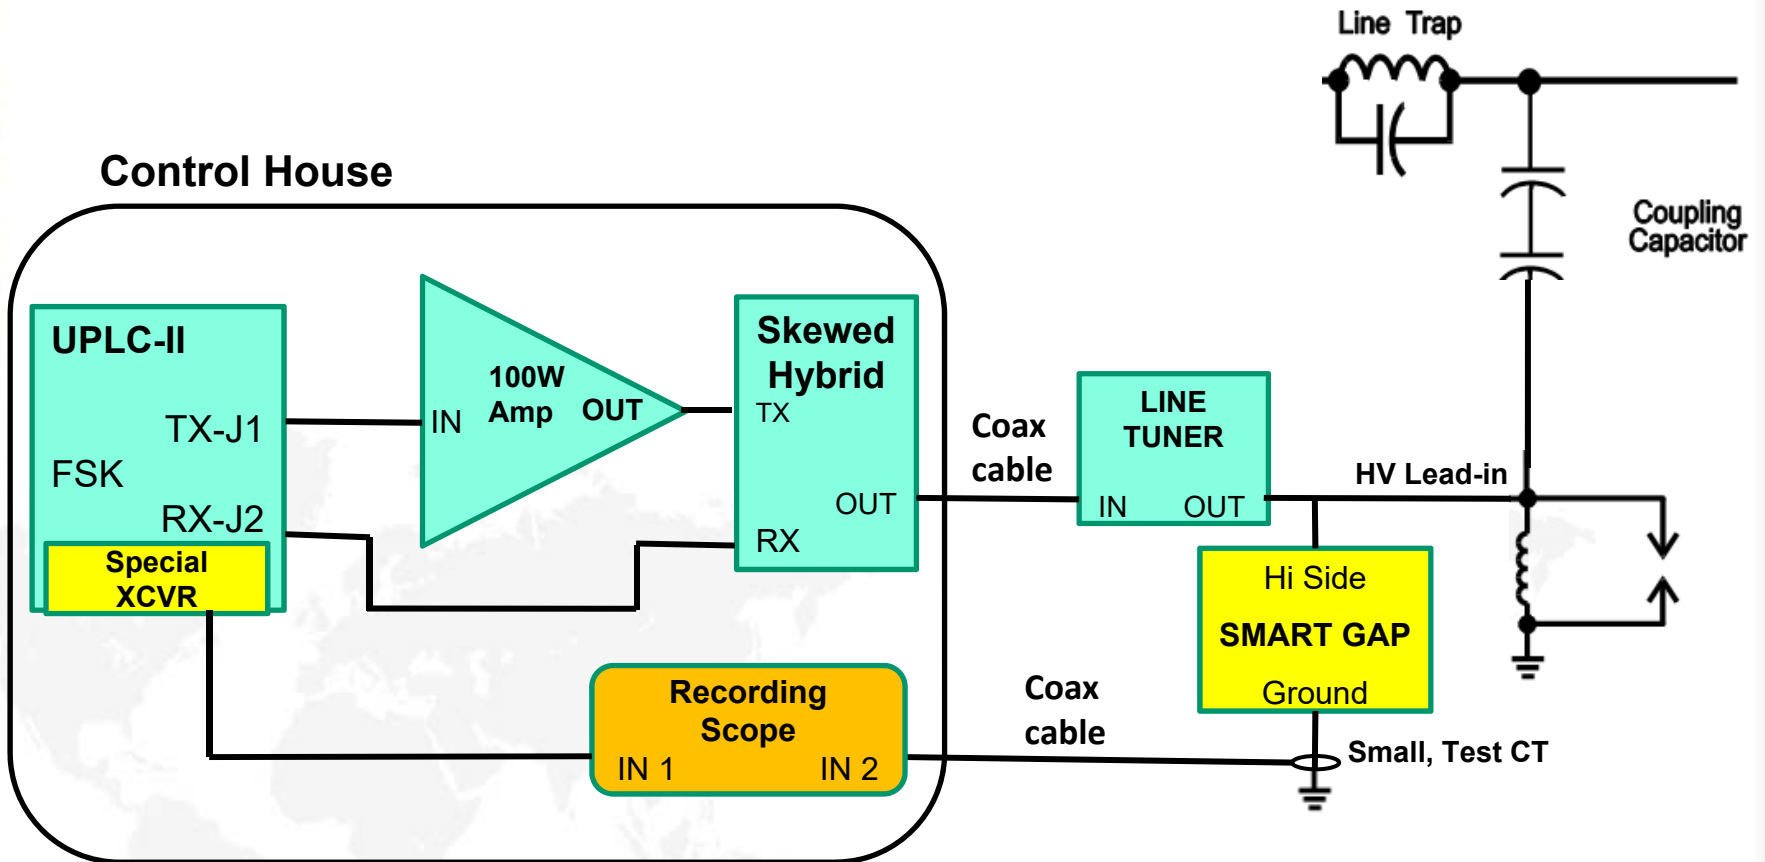
Field Test Set Up for Testing Carrier Ho

1. A field test was performed with surges created from opening a disconnect switch which revealed that a volley of surges will cause **all** gaps, in line tuner & CCVT, to fire even with a lower voltage smart gap.
2. To prevent carrier holes, the field test revealed the need for all **gaps** in the system to be properly spaced air gaps in good condition or they need be replaced with a Smart Gap.
3. The field test showed that a lower firing voltage gap could not prevent other higher voltage gaps that were electrically in parallel with it from firing.
4. UPLC-II SOEs showed many **loss of channel** events ranging from 3 – 13 msec with the standard gas tube gap in the CCVT or Line Tuner.

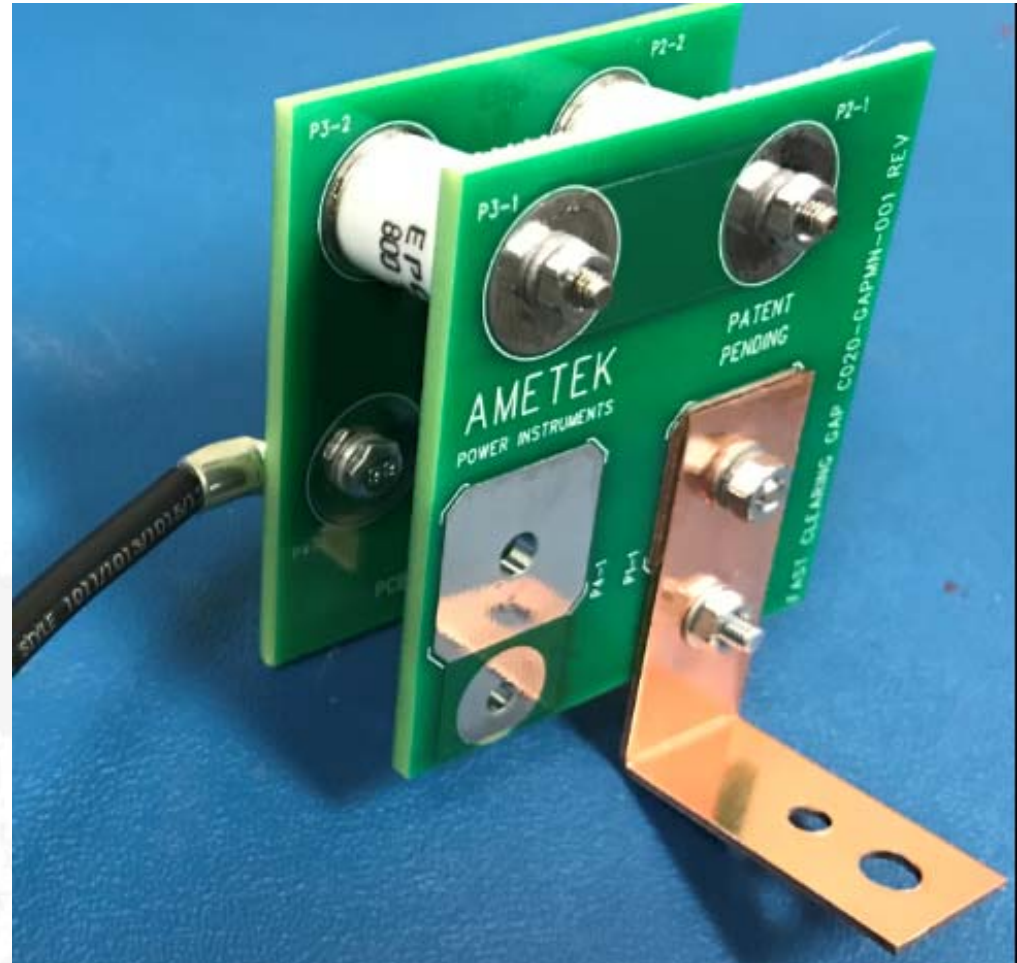
Ametek “Smart Gap” (patent pending)

1. **Multiple high hold-on voltage gas tubes in series are required to get above the holding voltage that prevents conduction.** Three high holding voltage tubes did the trick. Stopped 100% of carrier holes under the worst case conditions we could simulate for single surges. (Carrier holes without the smart gap in the same exact setup were occurring over 50% of the time.)
2. We noticed several failures of the standard 8 mm gas tubes used in the line tuners during our tests, so we chose to use a more robust 12 mm gas tube in the Smart Gap. After thousands of surges there was no sign of any degradation (unlike the 8mm gas tubes where several failed).

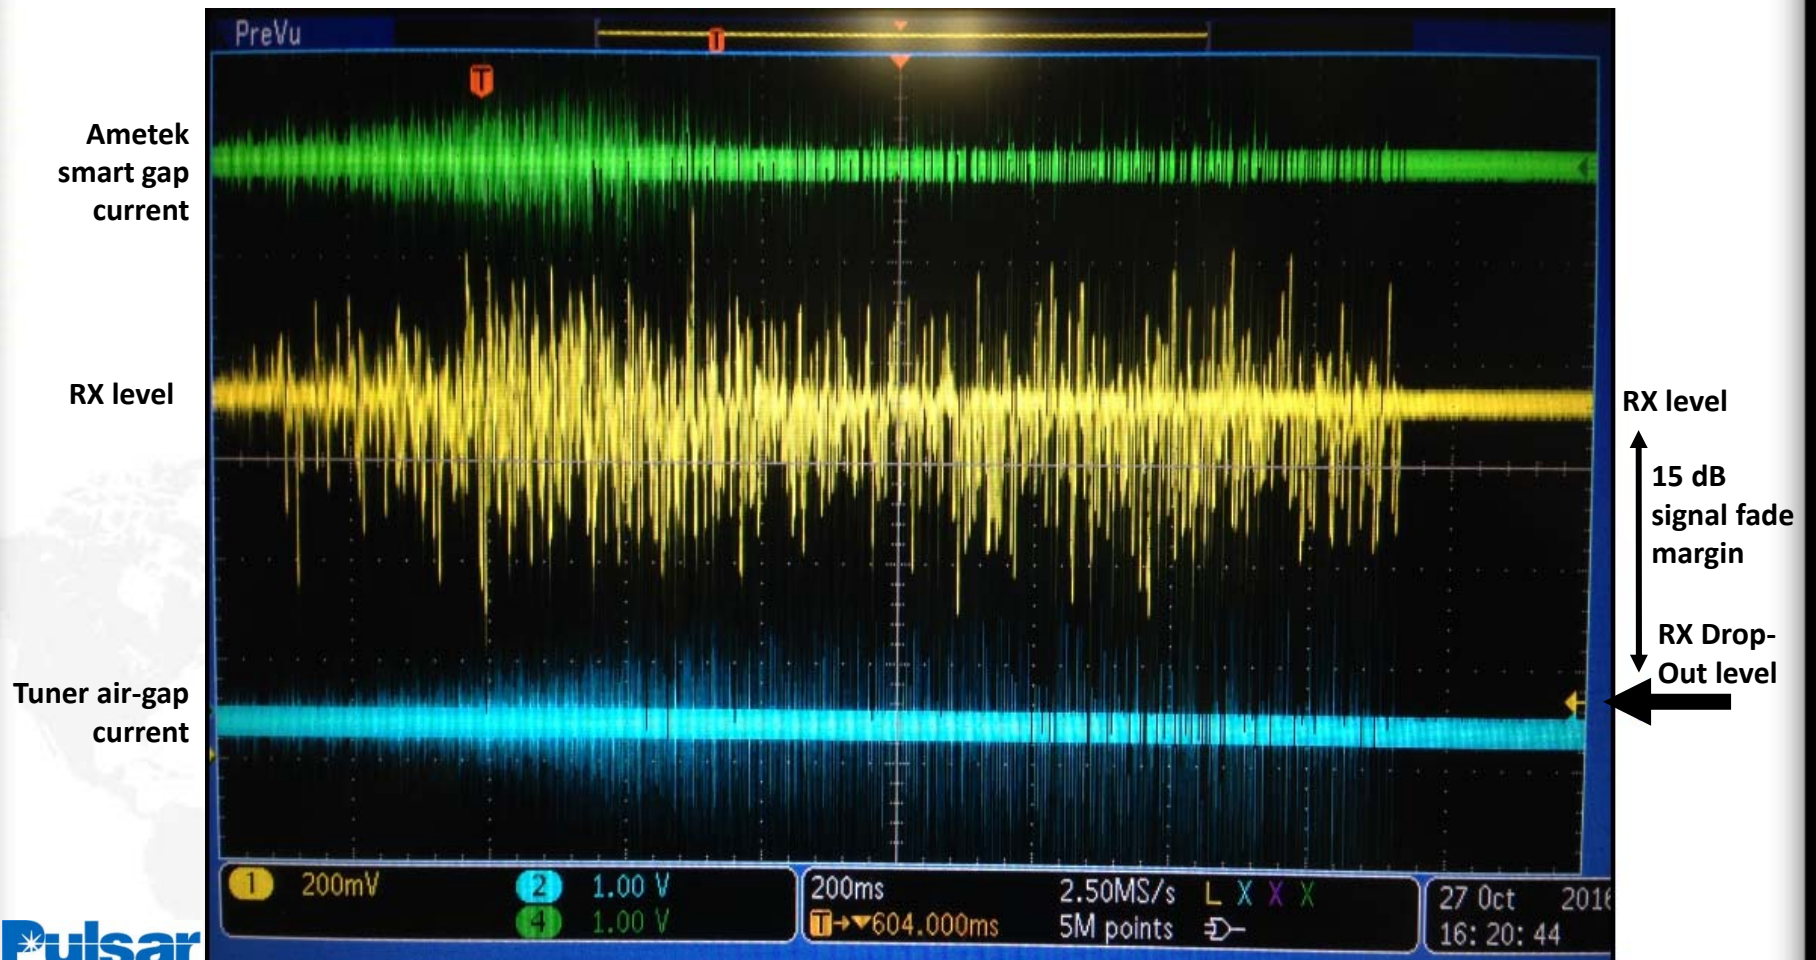
Field Test Results with Ametek Gap in CCVT

1. In the field, our **smart gap prevented all carrier holes** for a 2 second volley of surges created by opening/closing a disconnect switch, as long other gas tubes gaps were not in the tuner or CCVT. This was supported by looking at a high speed RX output of the UPLC-II plus the lack of any SOEs occurring during the 2 second blast of surges.
2. Similarly properly set/maintained air gaps prevented carrier holes and only showed a single 1 msec single fade alarm SOE.
3. The **voltage transient from a real world fault** is probably not a 2 sec blast of transients from a disconnect switch opening/closing and neither is it a single 1.2 x 50 microsecond transient but probably is somewhere in between.
4. Final proof will come as utilities change their spark gaps and monitor the SOEs in their systems to verify no loss of carrier signal during faults.
